SMALL BUSINESS PREVENTS DAMAGE TO INVENTORY

THE POOL MAN, INC

Clarksville, Indiana

Project Profile

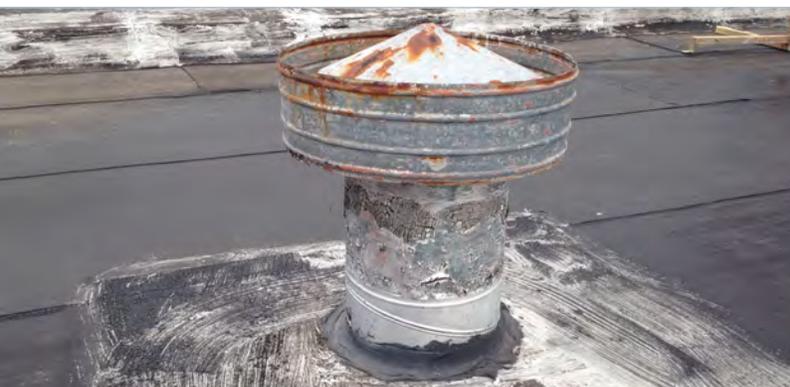
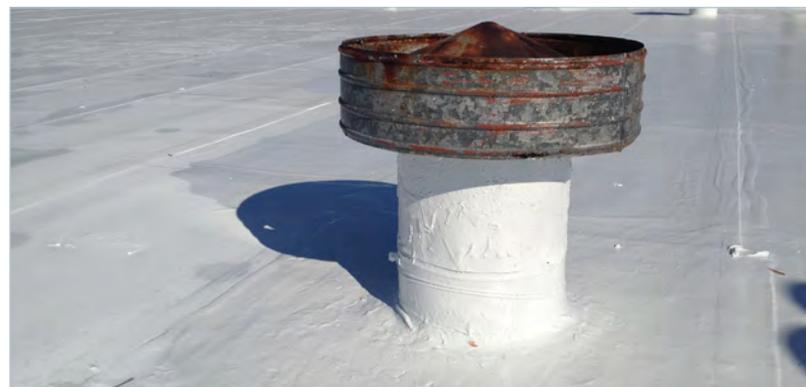
The previous roofing system, a smooth-surface built-up roof, had severe wear and tear around all protrusions and building edges. These areas were treated with a three-course silicone system that consisted of coating-fabric-coating to ensure a water-tight seal.

- Power washed the smooth surface built-up roof to remove all dirt and grease stains.
- Swept the roof surface to remove any debris left behind from the power washing.
- Any damaged areas and lap seams were fixed using a 3 course coating-fabric-coating system.
- Protrusions in the roof surface such as vents also received the 3 course system.
- Coated the field of the roof with 100% silicone coating once lap seams and protrusions had dried.

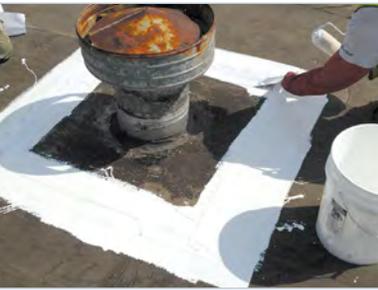
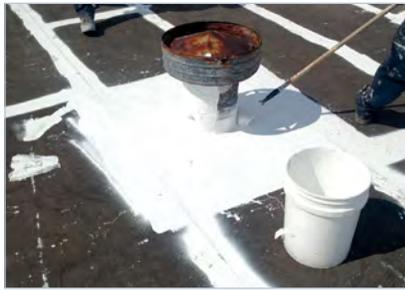
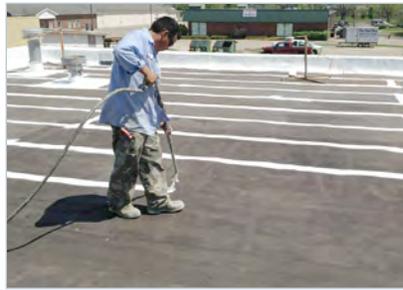
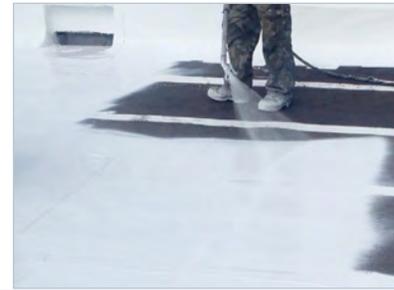
All protrusions in the roof were treated with a three-course silicone system that consisted of coating-fabric-coating and received coating on the entire fixture. This ensured a watertight seal where the old system was vulnerable to leaks.

Seams in the roofing system received an extra coating of silicone coating prior to coating the field of the roof. The seams are the most leak-prone areas of any roof, so the extra step was necessary for a watertight system.
