CONTRACTOR MARVELS AT FIRST USE OF SILICONE RESTORATION SYSTEM

Lynnwood, Washington

Project Profile

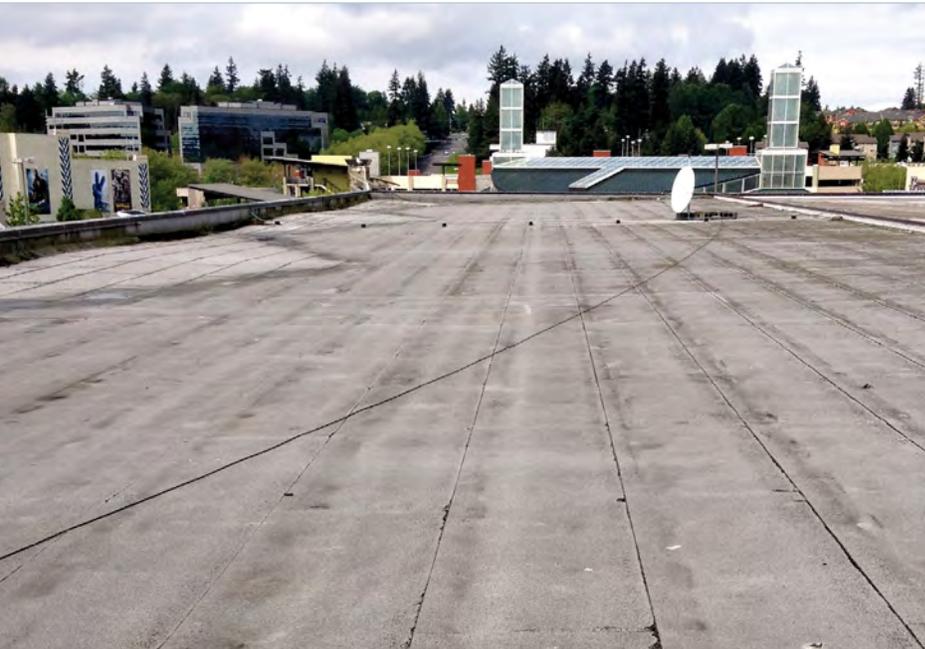
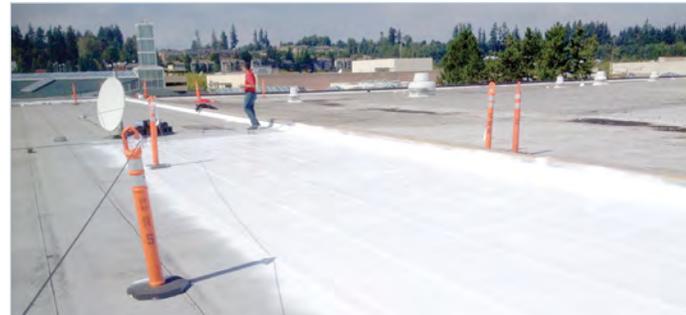
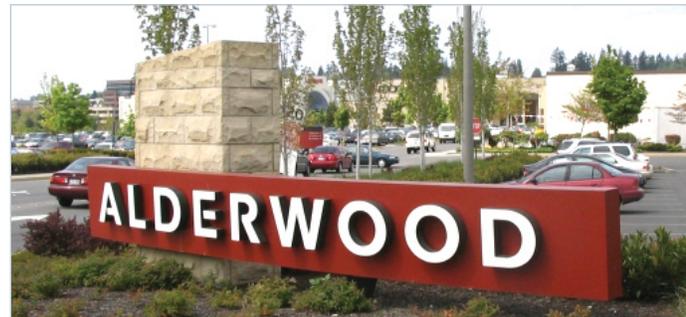
The Macy's roof in Lynnwood, Washington showed severe signs of deterioration and water damage. After patching and repair work was completed, the Progressive RCR process provided a waterproof, sustainable system that pleased Macy's facility management.

- Power wash the existing BUR roofing system.
- Damaged areas were 3-coursed with silicone and polyester reinforcement.
- All wet areas were removed and replaced.
- All laps were sealed with 25 mils of silicone coating.
- Entire roof surface received 40 mils of silicone coating.
